COMPLAINT TO COMPEL APPRAISAL AND BREACH OF CONTRACT

RE: Scope of Damage
Anderson Property
119/121/123 N. Poplar Street
Dresden, Tennessee
DOL: December 10, 2021
Claim No.: PR-400470
EM File No.: 1000353220
YAES No. ES-20220593

At your request, Mr. Matt Buckner, PE, of YA Engineering Services, LLC (YAES) visited the building at 119/121/123 N. Poplar Street in Dresden, Tennessee on May 4, 2022. It was reported that the building sustained damage during a tornado on December 10, 2021. The purpose of this investigation was to determine the extent of these damages and provide a preliminary scope of repair. This report contains a narrative followed by Figures 1 through 25, for a total of eighteen pages.

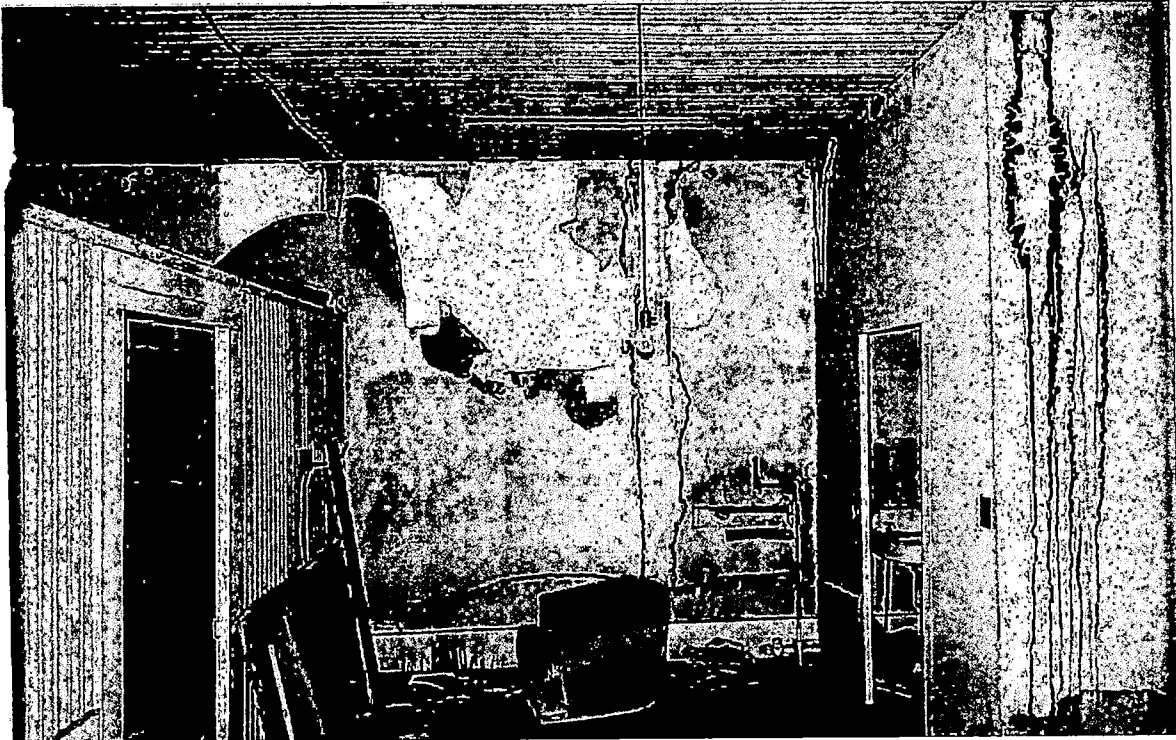
Figure 3. Note damage and staining to interior finishes, due to long-term exposure to water infiltration from roof.

Figure 3. The report incorrectly determines that all of the damage and staining (above left) is due to long-term exposure to water infiltration from the roof. However, this assertion is wrong and cannot be substantiated as there is no methodology available to accurately date water stains and the factual background of the roof conditions and evidence of the upper floor conditions were unknown to the author on the date of photos and the publishing of this report. The stain on right was taken on December 2021 and the one on the left was taken May 4, 2022. but we know for sure that it was the new water that damaged the first floor because it had to have originated from the damaged roof at the time of the loss. (see affidavit)

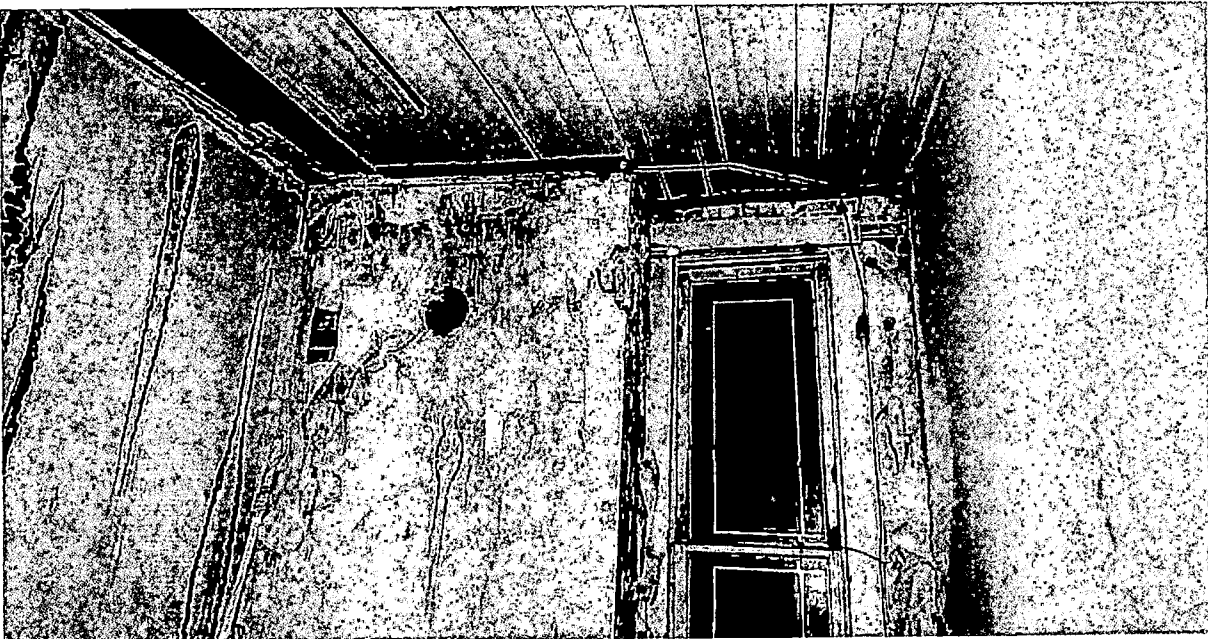
Figure 4. Note damage and staining to interior finishes, due to long-term exposure to water infiltration from roof.

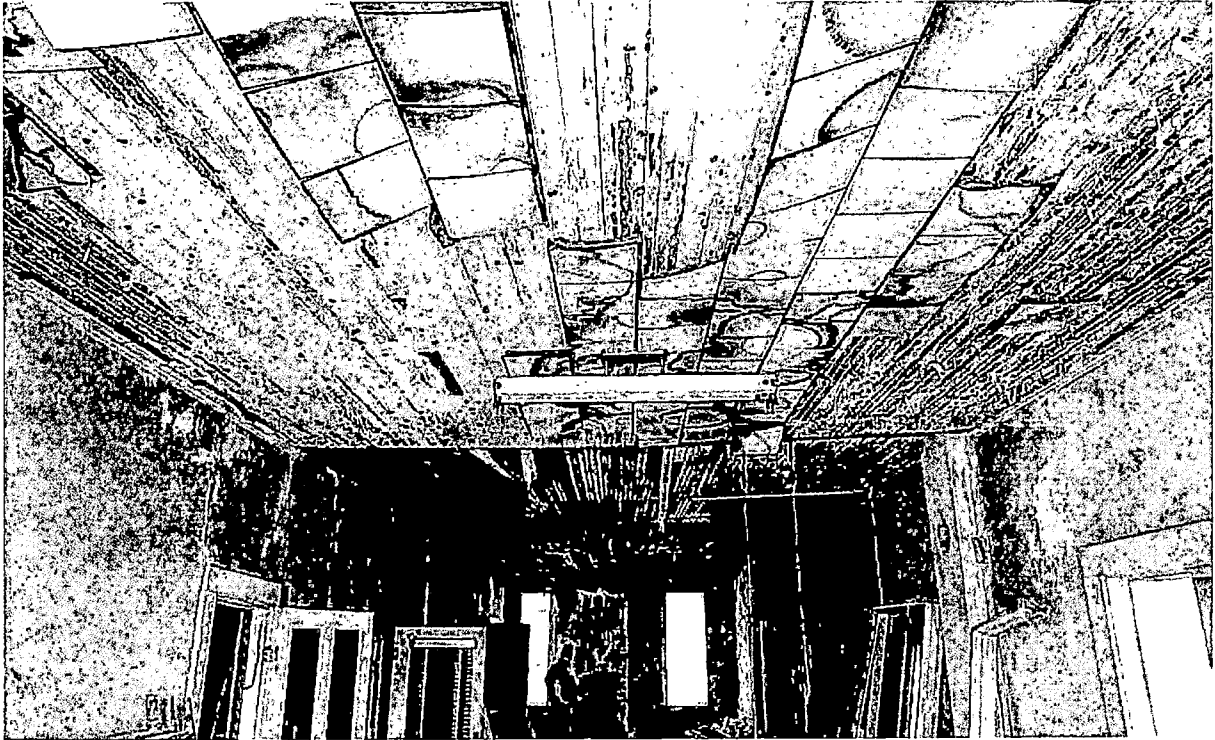
Figure 5. Note damage and staining to interior finishes, due to long-term exposure to water infiltration from roof.

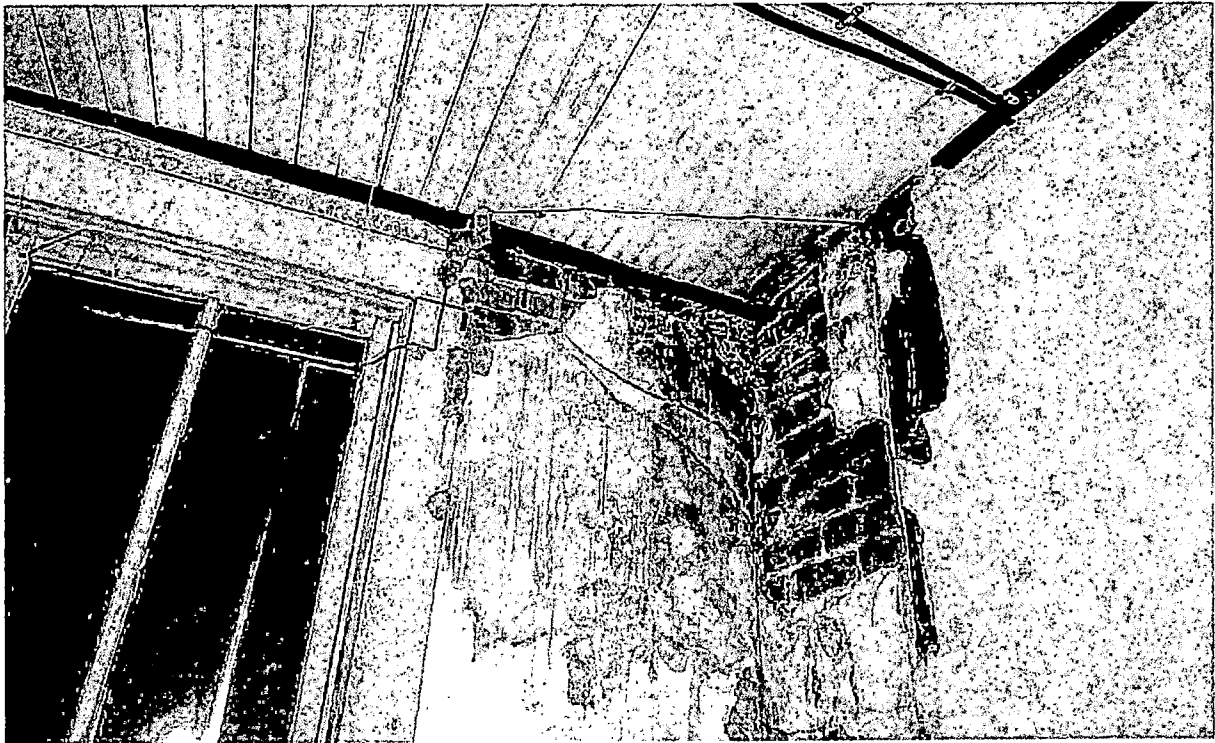
Figure 6. Note damage and staining to interior finishes, due to long-term exposure to water infiltration from roof.

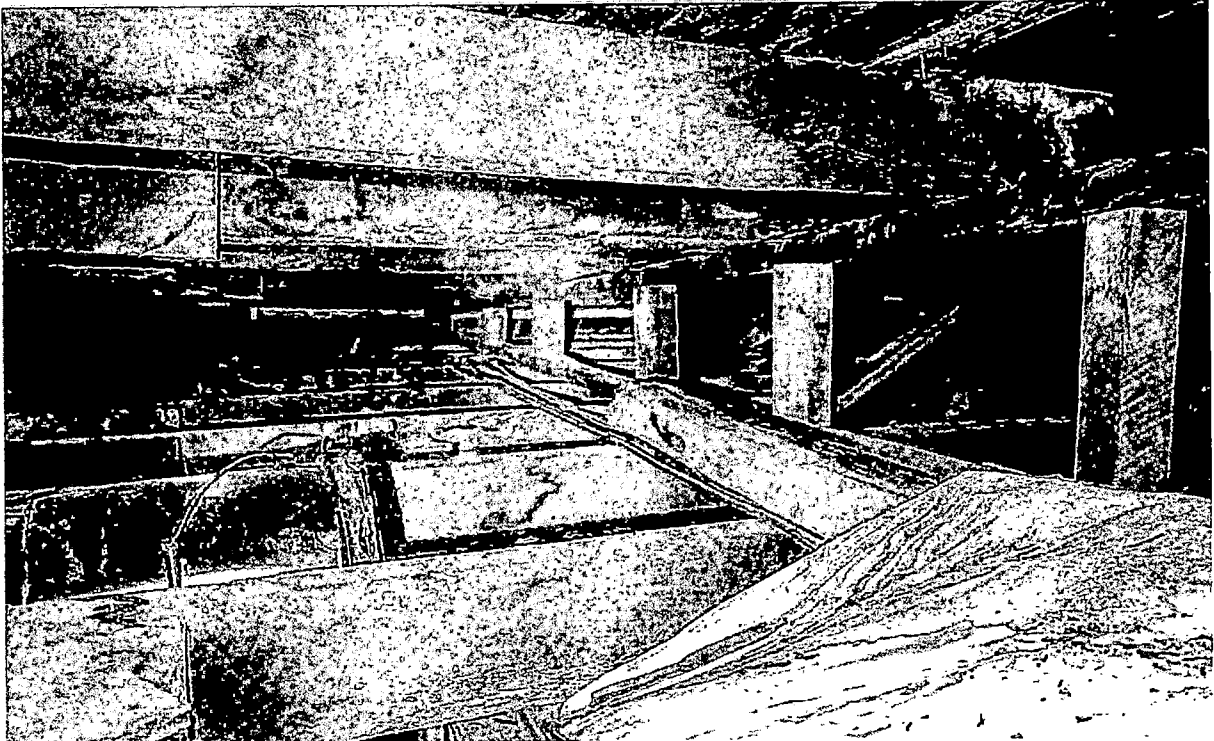
Figure 7. Note damage and staining to wood roof framing, due to long-term exposure to water infiltration from roof.

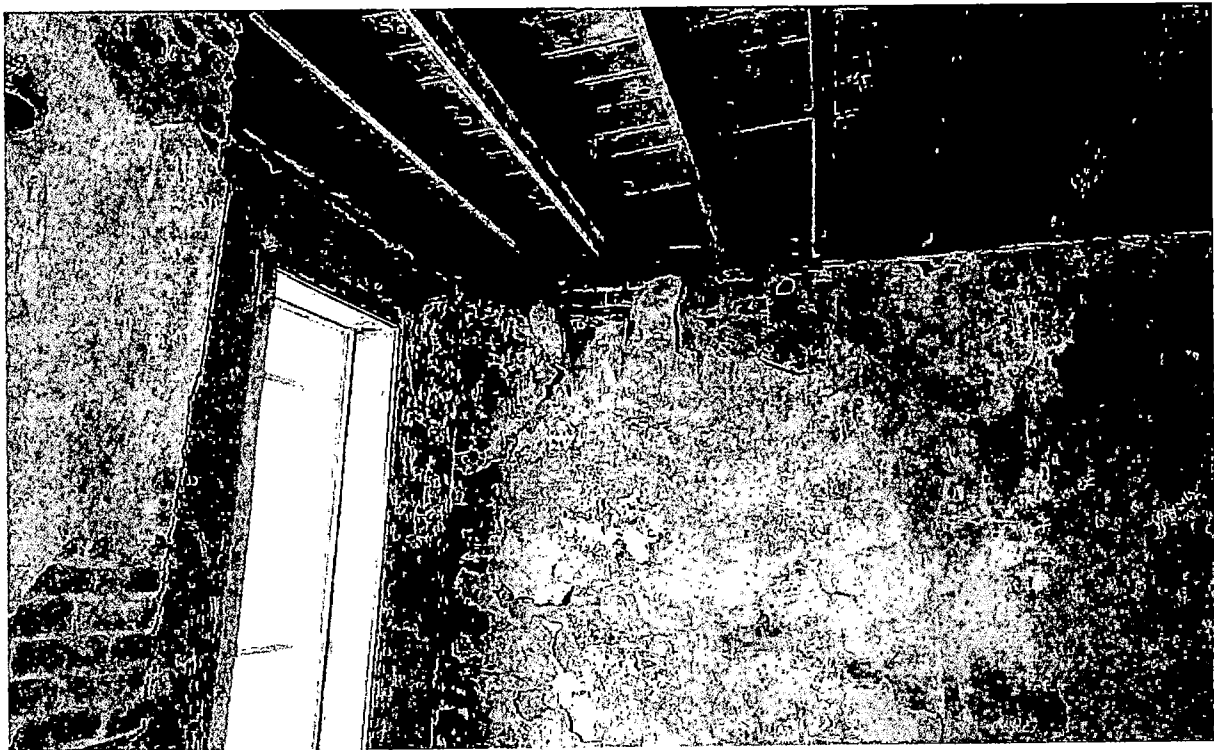
Figure 10. Note damage at interior plaster finishes beneath replaced roof framing members, due to long-term exposure to water infiltration from roof.

Compare Report (Fig. 10,11) New damage to plaster. Not long-term. Wood lathing is not severely stained.

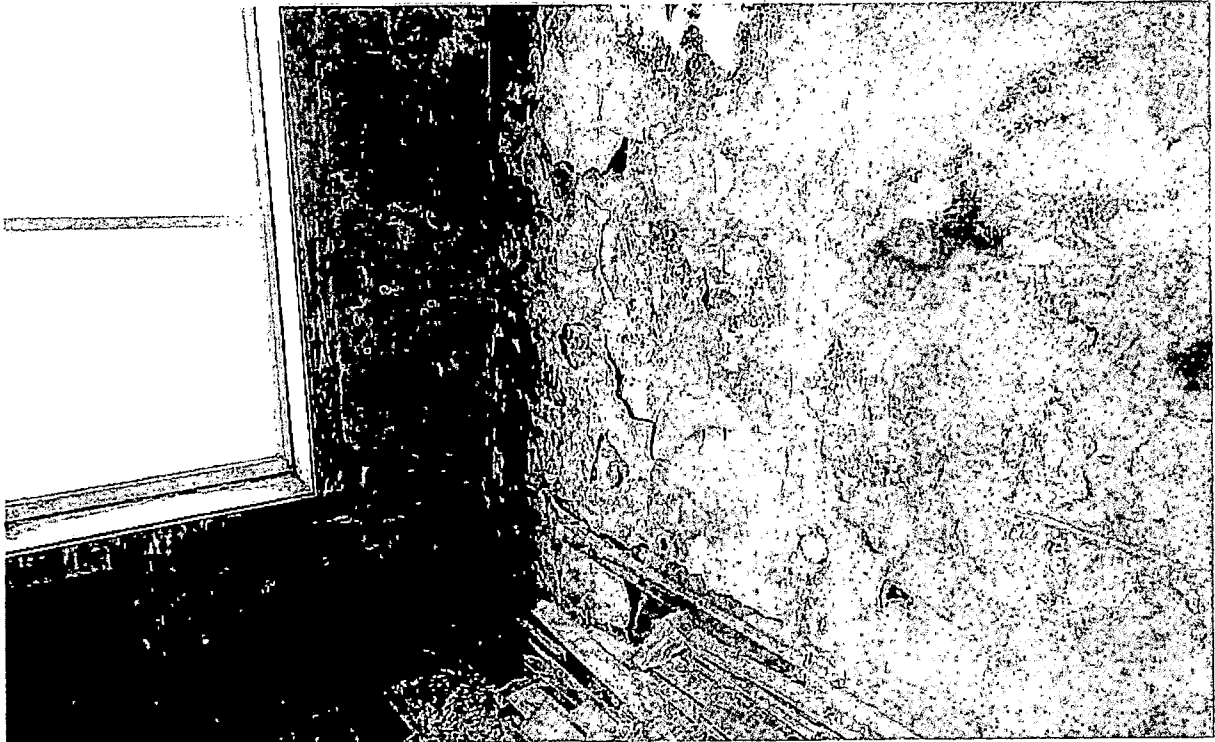
Figure 11. Note damage at interior plaster finishes beneath replaced roof framing members, due to long-term exposure to water infiltration from roof.

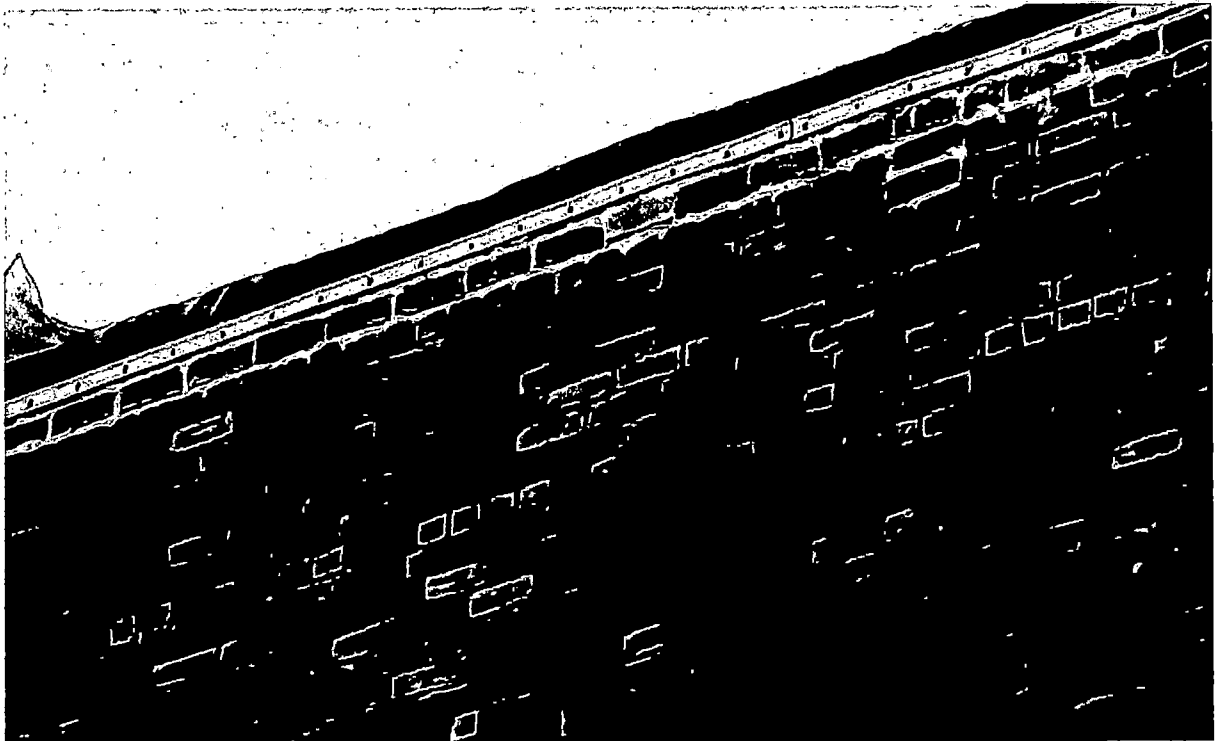
Figure 16. Note differing styles of clay bricks at exterior of building.

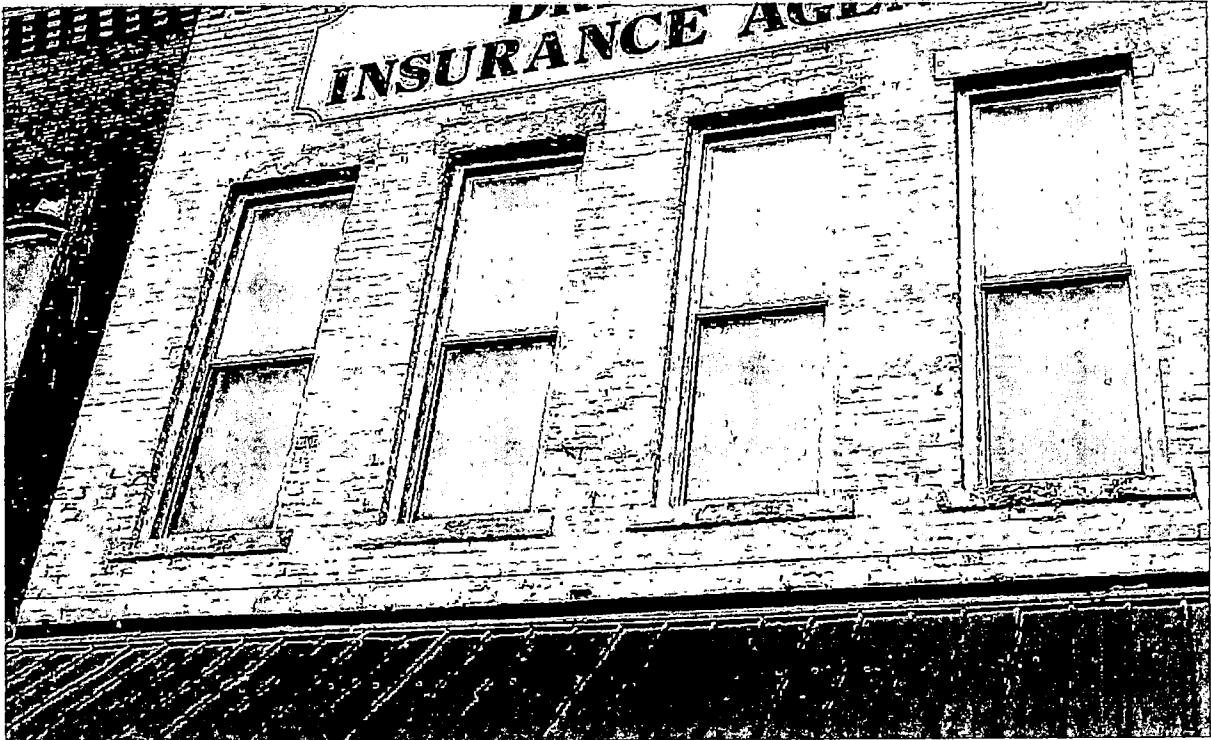
Figure 18. Note clay bricks at front exterior wall are covered with deteriorated paint.

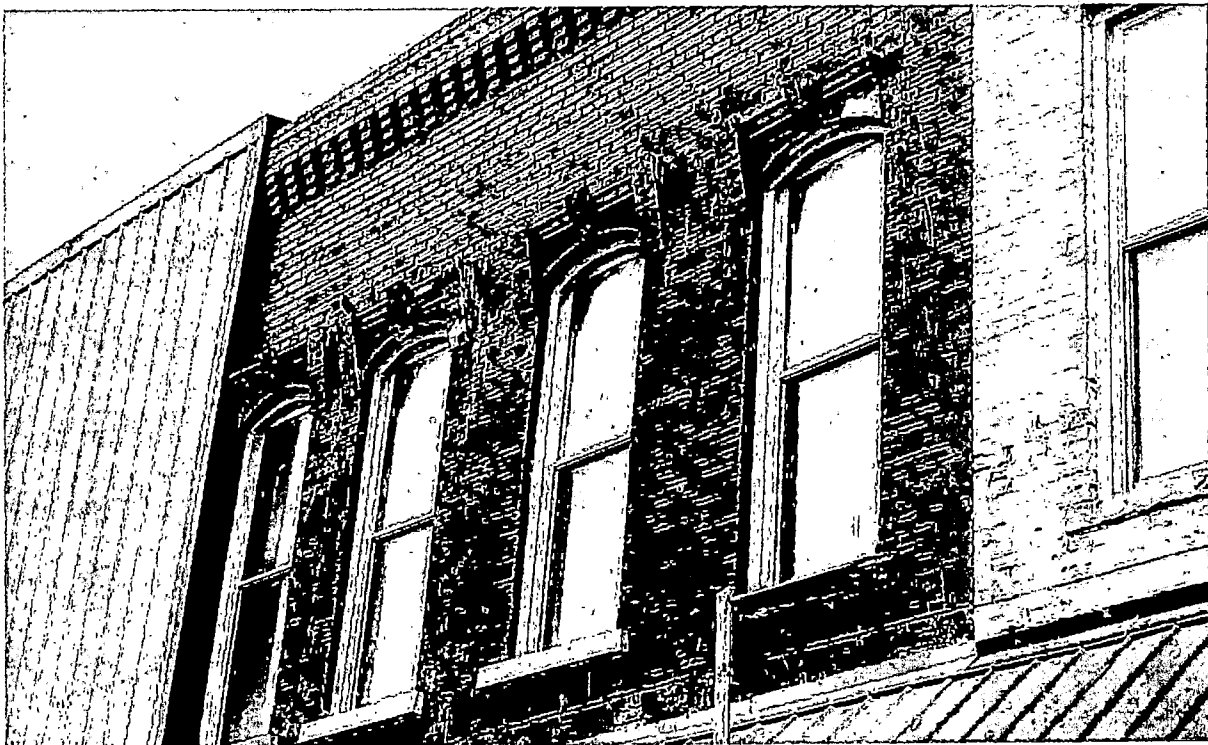
Figure 19. Note clay bricks at front exterior wall are covered with deteriorated paint.

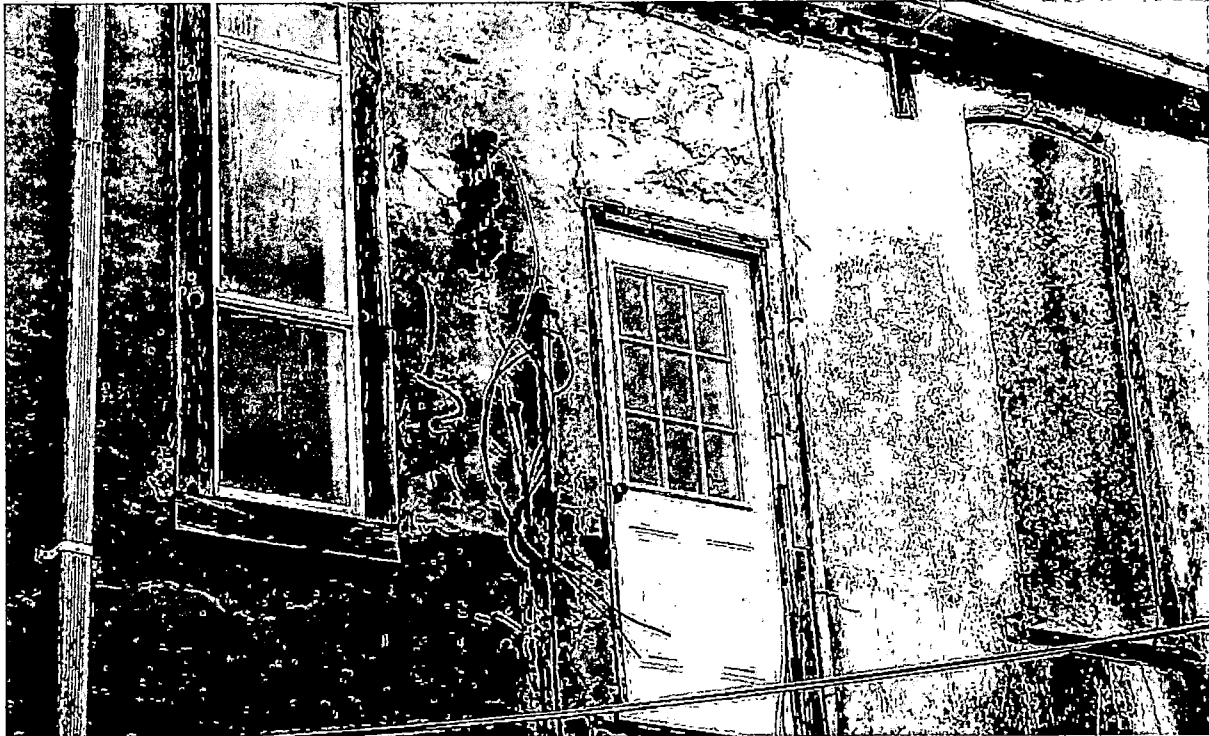
Figure 20. Note clay bricks at rear exterior wall have been repaired with various plaster coatings.

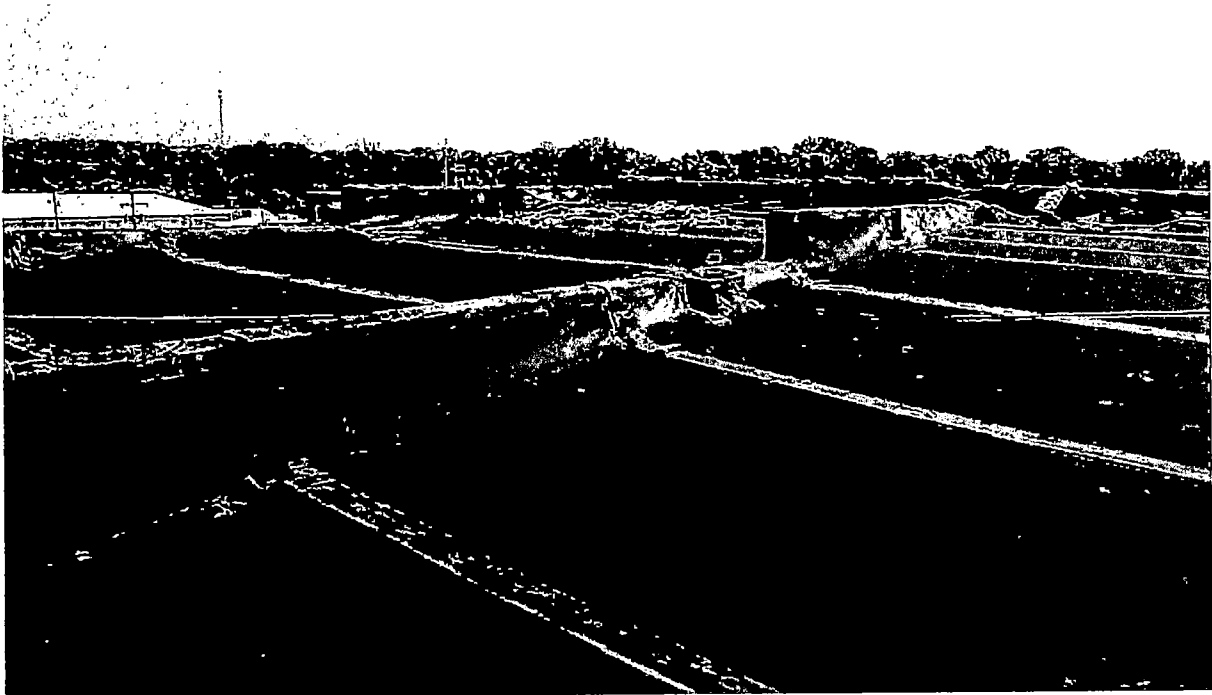
Figure 23. Overview of EPDM roof cover from rear of roof.

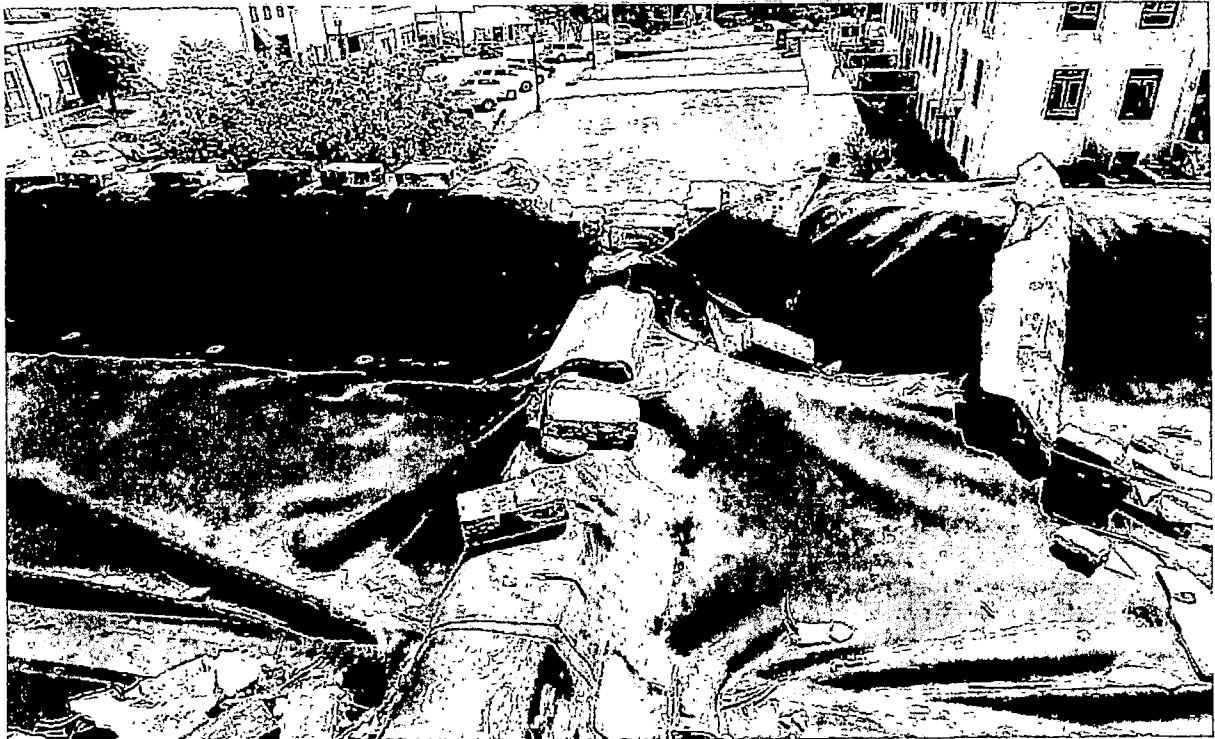
Figure 24. Note wind damage to EPDM roof cover at front portion of roof.

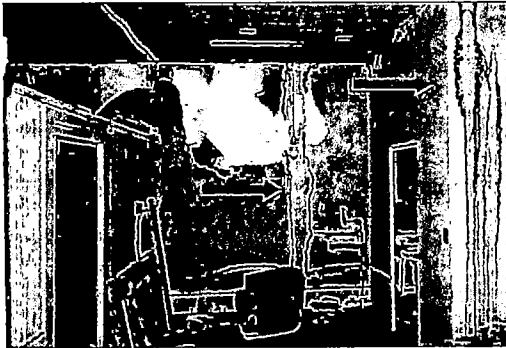
1) This opinion is refuted by the fact there is no long term water damage to the interior ceiling and wall finishes as the roof has not leaked in many years. (see affidavit) The *severe* staining described in the report is from the old stain conditions that were present at purchase, sustained tremendous amounts of water intrusion caused by the wind damages to the roof. The water entered through the opening created by the high winds and wind driven debris causing water to pour through the roof deck onto the framing, upper and lower walls, ceilings, and floors. Water entered into the multi wythe structural brick walls when the masonry cap was blown off and

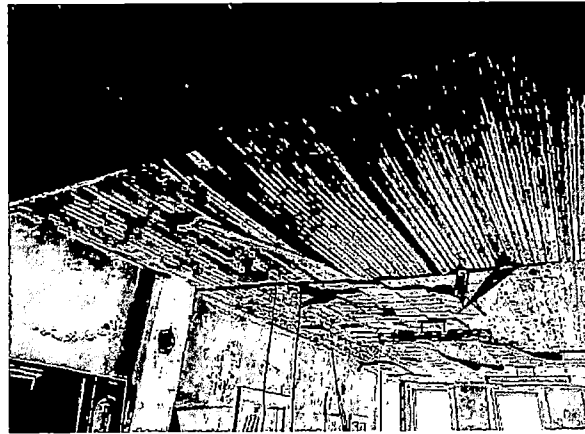
Fig. 2 Stains still wet from the tornado on the upper ceilings.

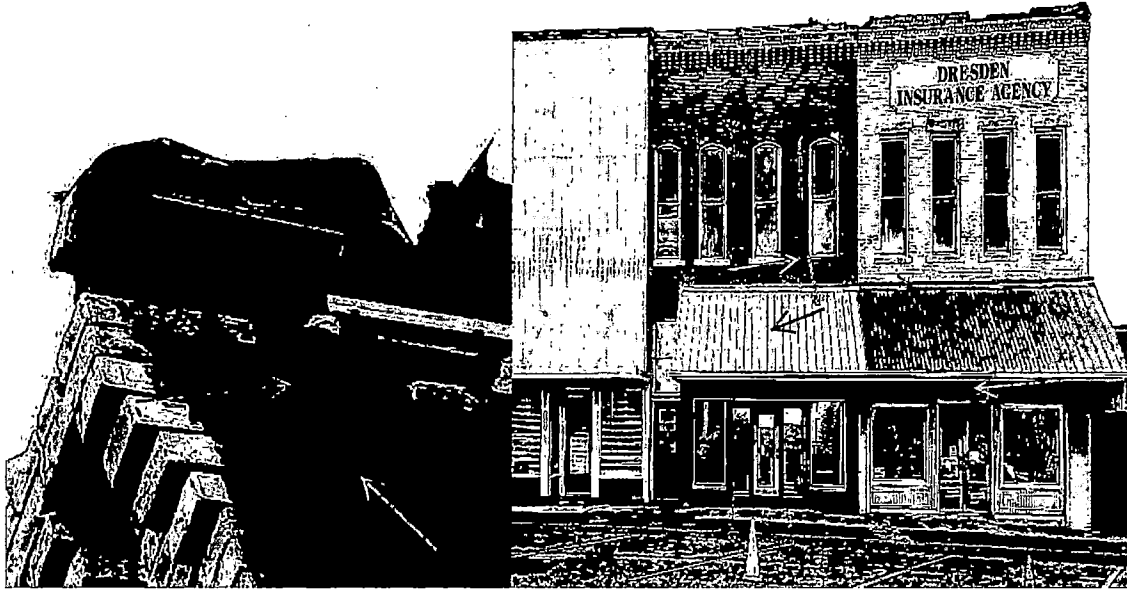
1. This observation is blatantly wrong because there are actually several courses of brick on the front and right elevations damaged from the tornado, and many were dislodged or have fallen and struck the metal roof and the ground due to the lightweight concrete and masonry cap being severely damaged by the tornado. The right elevation wall was damaged down to the mid-section due to the wind force. The only thing holding the first three courses together is the EPDM material and termination bar.

Fig. 1 Severe wind damage to the brick on top left of the front and right elevations has made the building dangerous and a substantial amount of money has been expended in trying to protect the property and prevent injuries. This photo alone refutes the opinions on scope and the amount of loss.

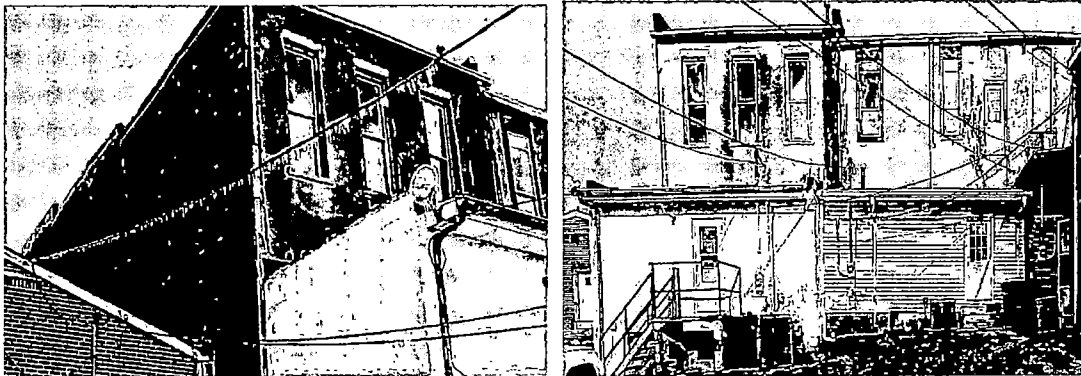
Clearly, the structural bricks have a consistent style, appearance, pattern, and function installed according to the methods of construction known in that era. Moreover, a proper repair of the structural walls cannot be accomplished due to the direct wind damages sustained, coupled with the condition of de-bonding throughout the exterior walls. Wind shear warped the right elevation wall. Also note the wind damaged windows on the front and rear elevations are not accounted for in estimates.

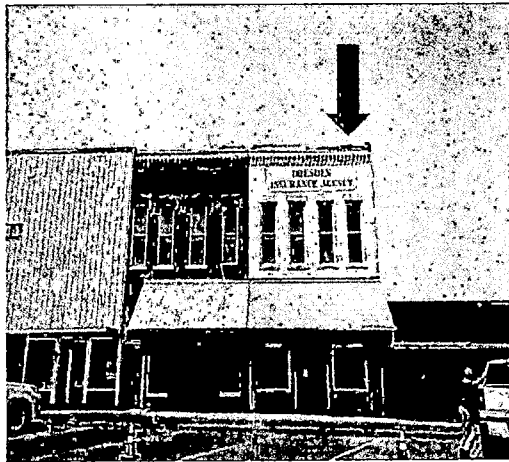
Fig. 13. Red arrows point to wind damage to top course of clay Bricks.

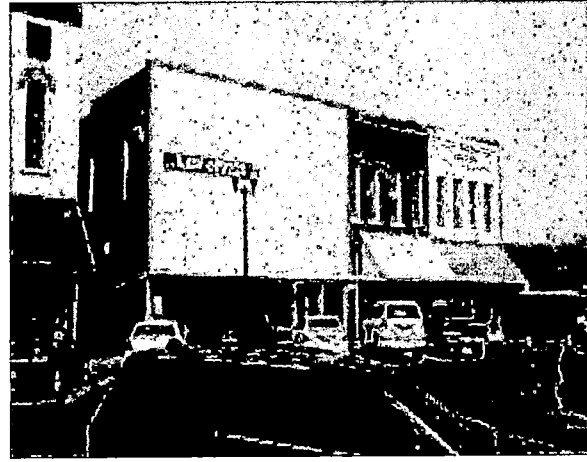
Fig. 13 Windows and canopies are severely damaged by wind debris. Window lentils and brick is damaged and debris falling from bldg.

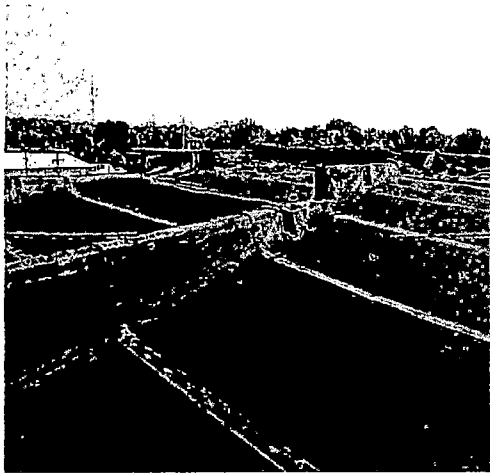
Figure 22 Overview of EPDM roof cover from front of roof
